Common Causes of Jaw Coupling Failures

Informational Bulletin

Mechanical Power Transmission Association

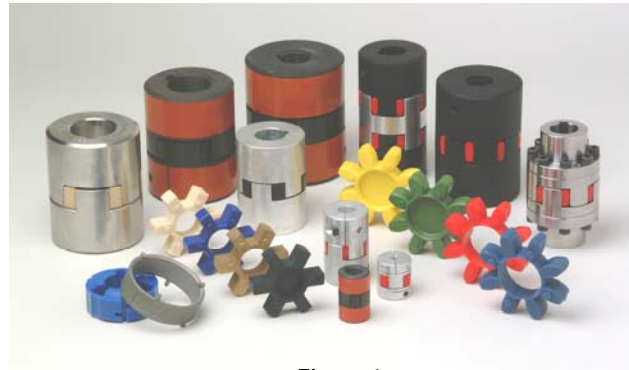
Figure 1

Inserts, or spiders, used in jaw couplings are designed to be the primary 'wear' component in the coupling. Understanding the difference between normal wear and abnormal wear is critical to proper coupling maintenance.

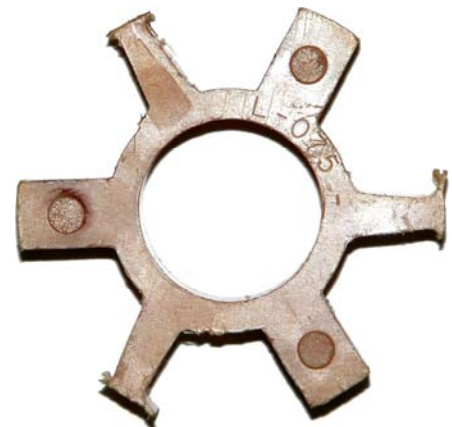
Figure 2

The elastomer, or spider, acts as a cushion between the metal jaws of the two coupling hubs. The driving hub pushes the driven hub through the spider resulting in an expected compression of the elastomer. Normal wear of a jaw coupling spider is not considered destructive wear but is instead a compressive "set" of the elastomer. Compressive "set" is defined as the decrease in the thickness of the spider leg as seen in figure 2 and is considered normal wear of the spider ages while in service.

This particular spider (figure 2) was used in a non-reversing application. The normal limit of allowable wear is roughly 20-30% of volume loss in the three spider legs that typically transmit torque.

Compression is only applied to the spider legs forward of the driving jaws and the trailing legs behind the driving jaws remain relaxed. Accordingly, when compressive set reaches 70-80% (representative of most manufacturers' standard) of its original spider leg volume, the spider needs to be replaced. If alternating spider legs display compression, the spider can be rotated by one leg advancing the good legs into the driving position. This is an acceptable step to take until a replacement spider can be installed. In reversing applications, all spider legs would show wear and the spider should be replaced immediately.

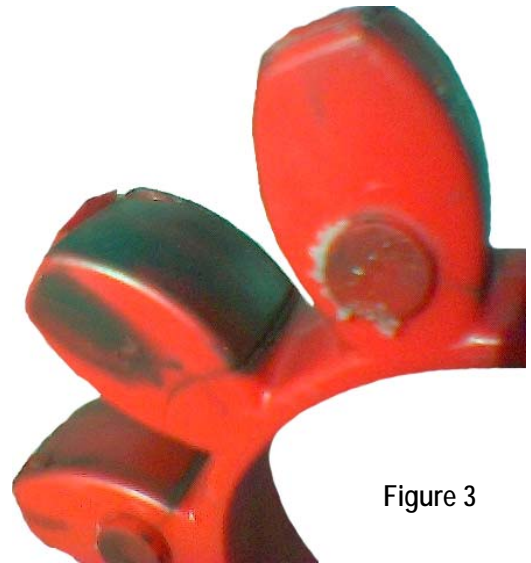
Figure 3

When a coupling fails due to misalignment, this type of failure is easy to identify provided the spider has not been destroyed. Angular wear marks on the tooth or leg of the spider are typical failure signatures caused by excessive misalignment as indicated in figure 3.

Knowledge of the amount of misalignment a coupling can handle and understanding how to identify failures due to misalignment can lead to better coupling selection and maintenance to increase coupling life. Coupling manufacturers generally provide detailed instructions for the selection and installation of jaw couplings. The installation instructions usually cover proper alignment procedures in detail and these instructions should be referred to prior to installing jaw couplings.

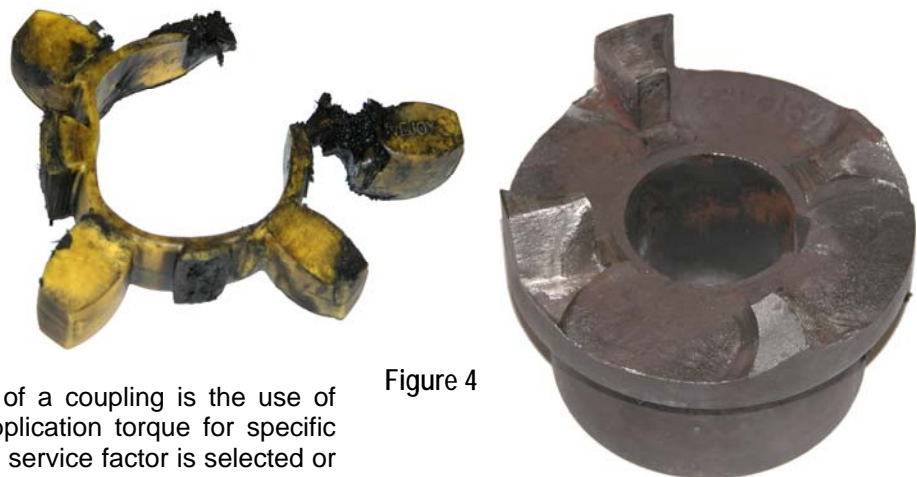
Figure 4

Couplings are designed to transmit torque from one shaft to another through the coupling hubs and spider. The weakest link in a jaw coupling is the insert, or spider, and the coupling's torque capacity is determined by the rated capacity of the elastomer to transmit torque. When the elastomers' capacity to transmit torque is exceeded, an over-torque, or over load, situation can exist. This happens when the coupling has not been correctly sized for an application and typically results in the failure of the coupling, sometimes catastrophic (see figure 4). A major

factor influencing the selection of a coupling is the use of service factors to adjust the application torque for specific applications. When an incorrect service factor is selected or this calculation is not done properly, spider failure and often hub failure will occur. Charts listing appropriate service factors for various applications are provided by

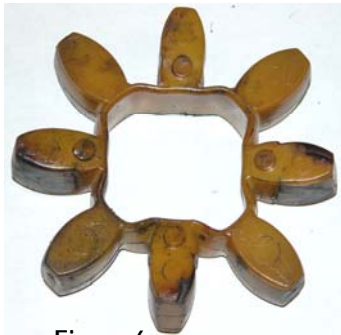
Figure 6

Straight and curved jaw over-torque failures appear as a severing of the legs from the spiders, causing the jaw on one hub to come into contact with the jaw on the opposing hub. The fact that the coupling will continue to operate, even though the spider has been destroyed, makes this a failsafe coupling. The spider should be replaced without delay, otherwise the jaws will break and the two pieces of machinery will be disconnected. Over torque in the curved jaw design can also take the form of a "squaring" of the open center of the spider as illustrated in figure 6.

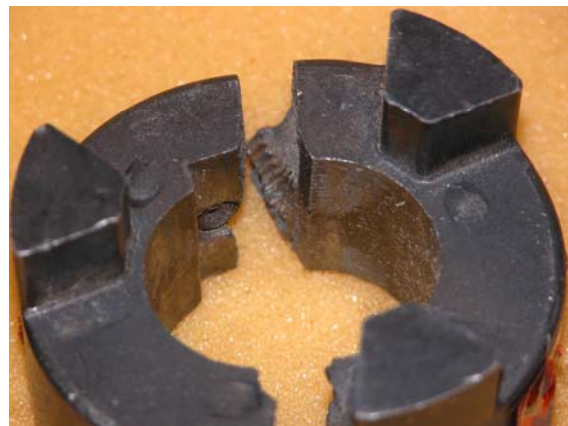
Figure 7

Another signature failure for a jaw coupling in an over load condition is what is referred to as "keyway burst" as illustrated in figure 7. The weakest link in any coupling is the amount of material between the top corner of a key way and the outside diameter of the hub. Applying excessive torque to a coupling can cause the hub to break starting at the top corner of the keyway. The end result is the hub will split in half as seen in the picture.

Understanding what coupling components look like after an overload condition can help you to better understand the importance of a proper selection practice.

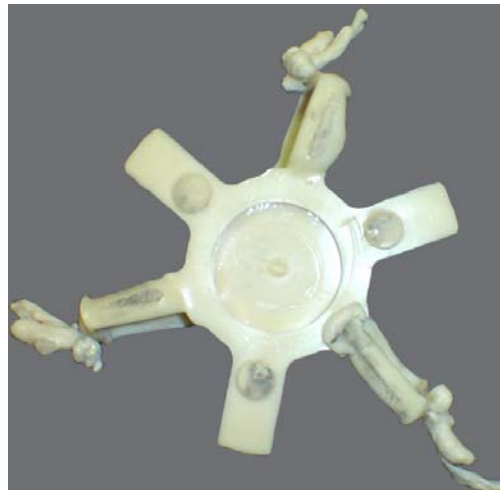
Figure 8

Reciprocating engines such as diesel, gasoline, liquid propane, and natural gas generate torsional, or high frequency, vibrations. Likewise, reciprocating pumps and compressors generate similar high frequency vibrations. These high frequency vibrations are not as easily detected as lateral vibrations that you can feel. If not dampened out of a system, these vibrations can cause damage to both engines and driven equipment. Due to the attractiveness of their low cost, jaw couplings are often selected for the purpose of dampening these torsional and lateral vibrations. Under normal operating conditions the elastomeric material, or spider, through a process known as hysteresis, will attempt to dampen these vibrations by converting the dynamic energy of the vibrations into heat through molecular friction, and then dissipate this as heat. If the coupling is not able to disperse the generated heat, the insert or spider material will build up enough heat to literally melt the spider from the inside out. The characteristic failure due to hysteresis appears as melted material 'oozing' or pouring from the end of the spider legs as seen in figure 8.

Different spider materials will display slightly different abilities to dissipate the heat, but without changing size or moving to torsional style couplings, the end result will usually be the same as seen in the picture. In limited cases, vibrations caused by reciprocating equipment can be dampened to a satisfactory amount through the use of a jaw type coupling. This process of changing elastomeric materials or hardness ratings involves using inserts with different torsional "stiffness" values and is referred to as "tuning" the system. By using "stiffer" or "softer" jaw coupling elastomers the natural frequency of the engine can be shifted away from the normal operating speed of the engine. With jaw couplings this is strictly a "hit or miss" adventure. When designing couplings into applications involving these high frequency vibrations, torsional couplings are often the best substitution.

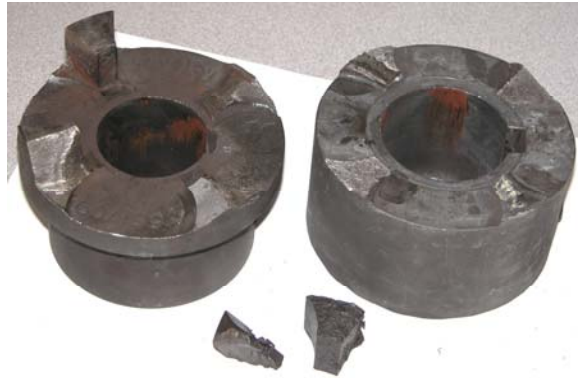
Figure 9

If worn spiders are not replaced, the legs will eventually wear or shear off leaving no cushioning between the hubs' metallic jaws. As stated previously, the coupling will continue to operate through jaw-to-jaw contact. This metal to metal contact will eventually cause jaw failure as illustrated in figure 9.

Even if the jaws do not break off from the hub, they may have suffered damage from the metal to metal contact. Hubs should be carefully inspected for cracks or chips before spider replacement.
